SAFETY INVESTIGATION REPORT

REPORT NO.: 01/2018

MV ARMATA **Fatal fall down the staircase** **in position 38° 48' N 118° 12' E** **16 January 2017**

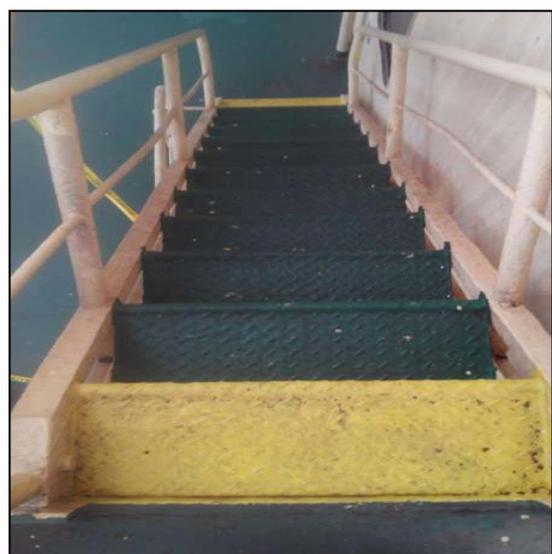
Figure 2: Staircase leading to the boat deck

On 16 January, at about 0450, safety and security checks were carried out from the bridge. The checks were reportedly uneventful. At 0540, however, the chief mate on the bridge wing caught a glimpse of a person lying on the boat deck, on port side (Figure 2).

The chief mate detected no pulse, respiratory or eye movement and the crew member was unresponsive. He immediately raised the alarm and called the master, who in turn reported to the Company, local P&I representative and ship's agent in Tianjin. From the injuries sustained by the casualty (hematoma of left eye, injuries on the back of the head and left outside palm), it was immediately suspected that the crew member had fallen down the staircase (Figure 2).

The blunt head injury affirmed by the autopsy report was compatible to a fall. A photograph of the staircase submitted by the master suggests a height of about three metres. It is very probable that the crew member fell down the staircase to the deck, resulting in a traumatic shock and possibly loss of consciousness. However, in the absence of any witness, the safety investigation was unable to establish precisely what had caused his fall.

- Although no precipitation was reported, the possibility of condensation on the cold staircase was not excluded, making the steps slippery;
- The slippers worn by the seaman may have caused him to slip down the staircase;
- The crew member may have missed his footing or handhold while carrying / using his mobile phone; and

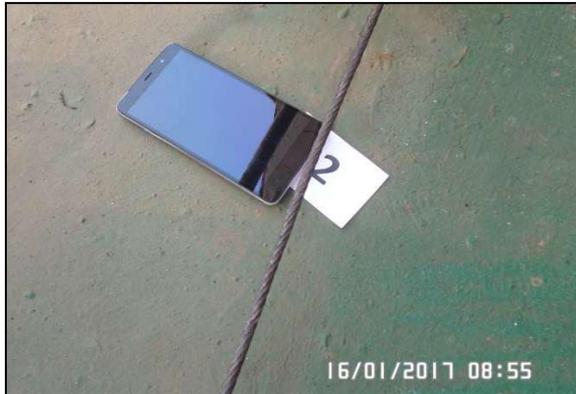
Figure 3: Mobile phone on the accident site

He hastened to the boat deck and noticed that the person was wearing shorts, a jacket and a pair of black jogging shoes, and lying motionless on his back near the ship's ladder. A mobile phone set (Figure 3) was close-by.
