# SAFETY INVESTIGATION REPORT

REPORT NO.: 21/2021

## **MV X-PRESS GODAVARI** **Fire in a container,** **while anchored,** **at Sandheads Anchorage, India** **28 September 2020**

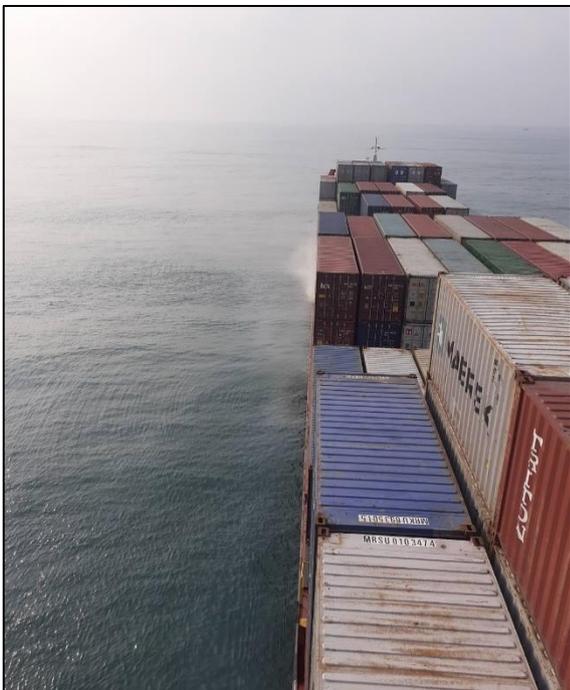
In the morning of 28 September 2020, during his 0400 to 0800 anchor watch, the chief officer noticed a container on deck emitting smoke (Figure 2). The master, who was also on the bridge at that time, noticed the smoke as well, and instructed the chief officer to investigate further.

**Figure 2: Visible smoke coming over the vessel's port side**

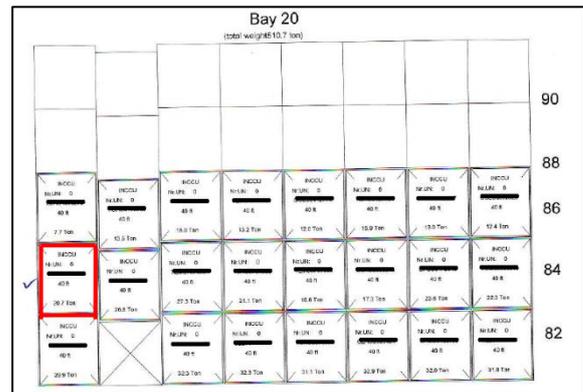
At around 0730, as soon as the chief officer reached Bay 20, he noticed smoke bellowing from a container in position Bay 20, Row 08, Tier 84 (200884) (Figure 3). He immediately reported this to the bridge and proceeded to the muster station. The master raised the general alarm at once and all crew proceeded as per vessel's fire contingency plan.

**Figure 3: Deck Bay 20 plan. Container emitting smoke, marked in red**

The container being shipped as general cargo on deck, was stowed on the outermost row of

Bay 20 and, thereby, exposed to direct sunlight. This, while it posed a fire hazard for the cargo inside the container, provided an early, readily visible warning of the fire to the crew. Had it been stowed under deck or had it started to emit smoke during the night, *X-Press Godavari* would have faced a very different and a more challenging situation.

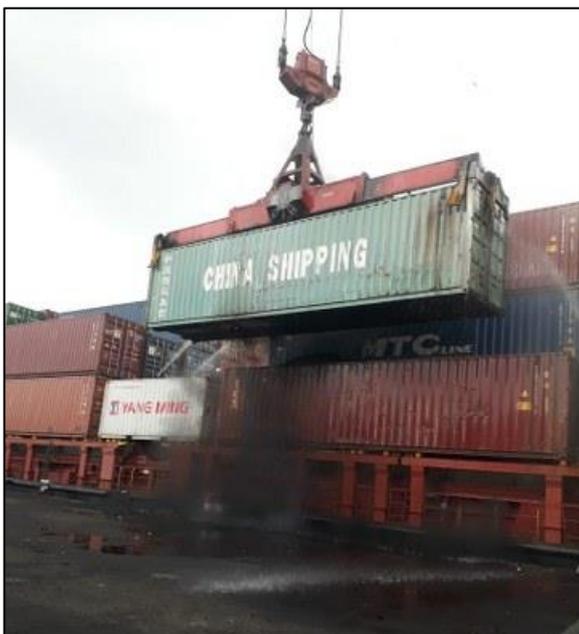
**Figure 4: Unloading of the container**

During unloading operation, a section of the bottom of the container was displaced, and part of the burning cargo fell on the roof of the container below. This was immediately tackled by the crew on board, while a shore fire-fighting brigade used foam extinguishing media to extinguish the fire within the container.

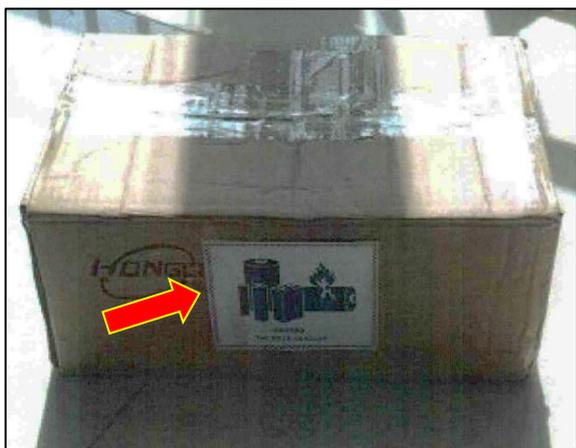
**Figure 5: One sample package marked with the lithium battery mark**

Although the packages inside the container was affixed with the lithium battery mark, the crew had no information on the cargo<sup>21</sup>.

3. SP 188 requires that packages be labelled with a lithium battery mark; however, it does not require the container, within which such packages are stowed, to be marked with the same, thereby rendering the vessel's crew unaware of the hazards within.
